Evaluation of the Structural Performance of CTS Rapid Set Concrete Mix®

Lucy P. Priddy, Haley P. Bell, Lulu Edwards,
William D. Carruth, and James F. Rowland

August 2016

Final report

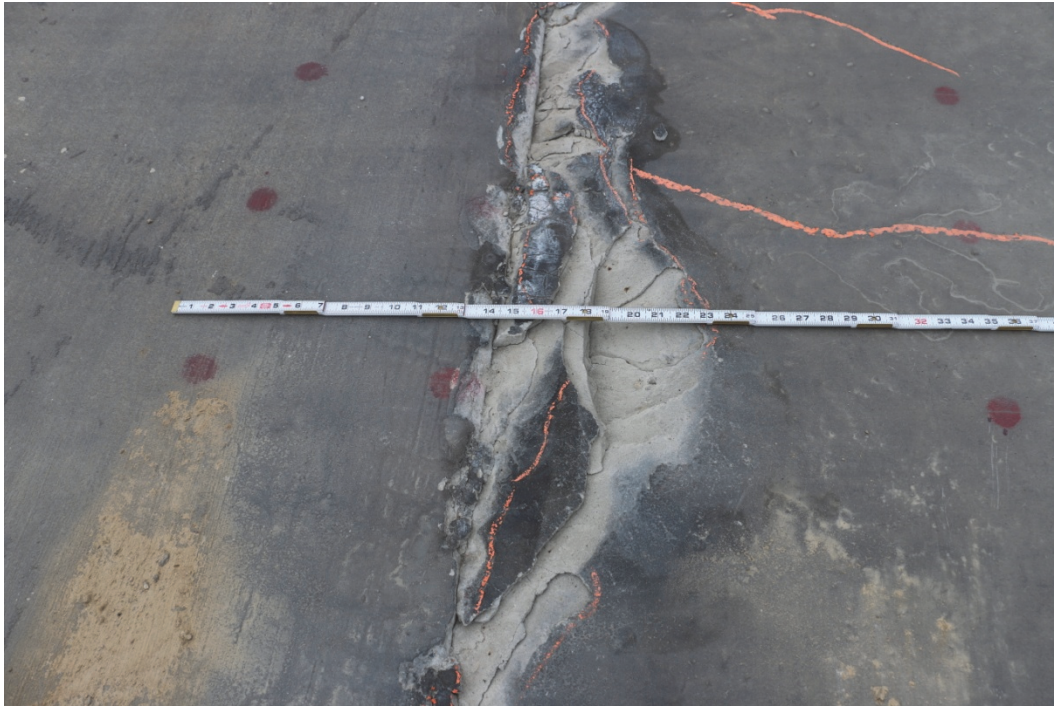
Figure 7. Joint spall presenting high FOD (swept) and tire damage potential.

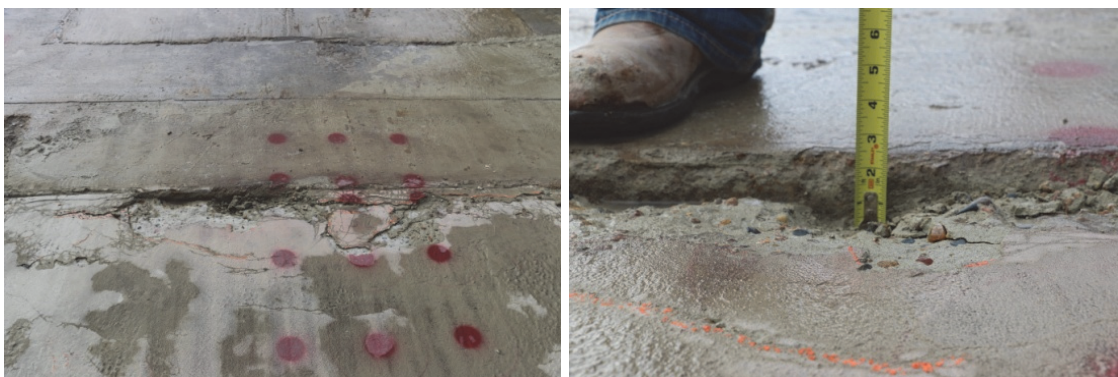
Figure 20. Series 1, Repair 1 - west edge at failure (560 passes).

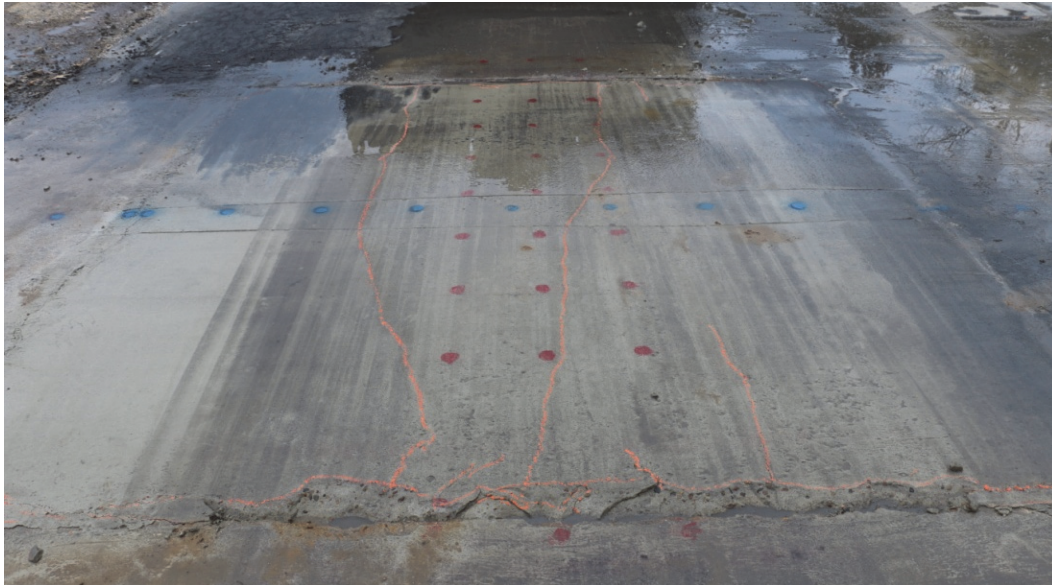
Figure 21. Series 1, Repair 2 - overall at failure (1,750 passes).

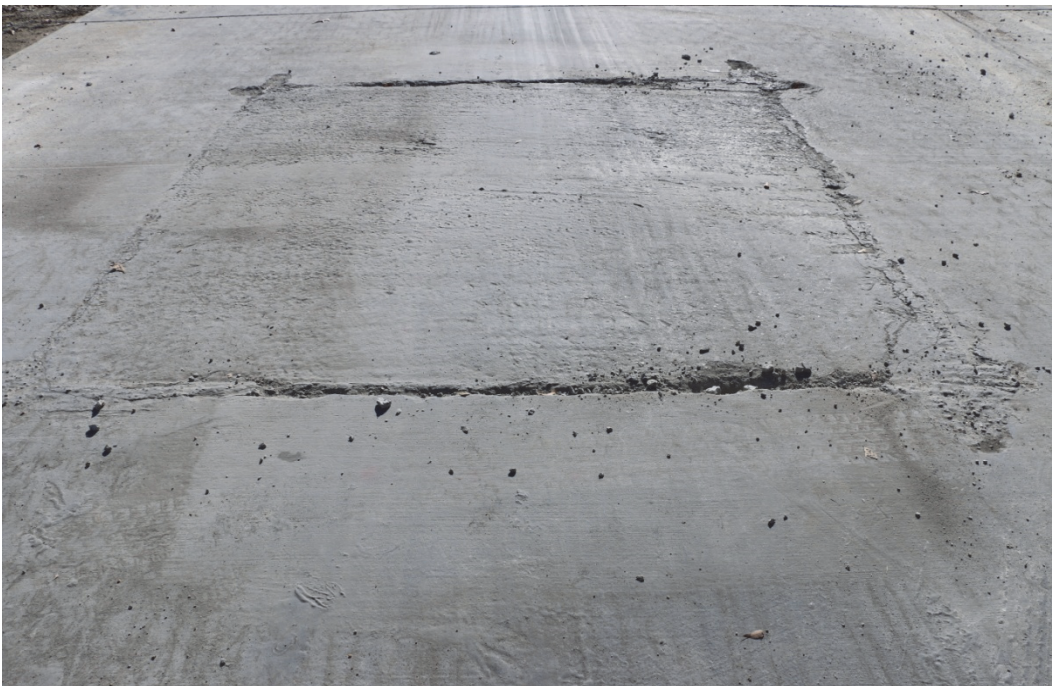
Figure 22. Series 1, Repair 3 - overall at failure (3,000 passes).

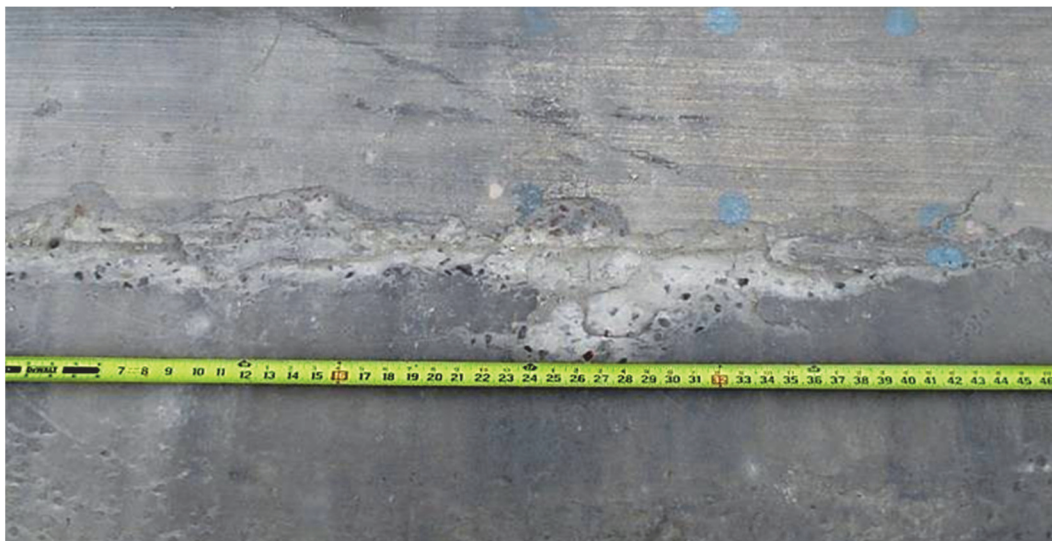
Figure 23. Series 2, Repair 6 - east edge at failure (1,300 passes).

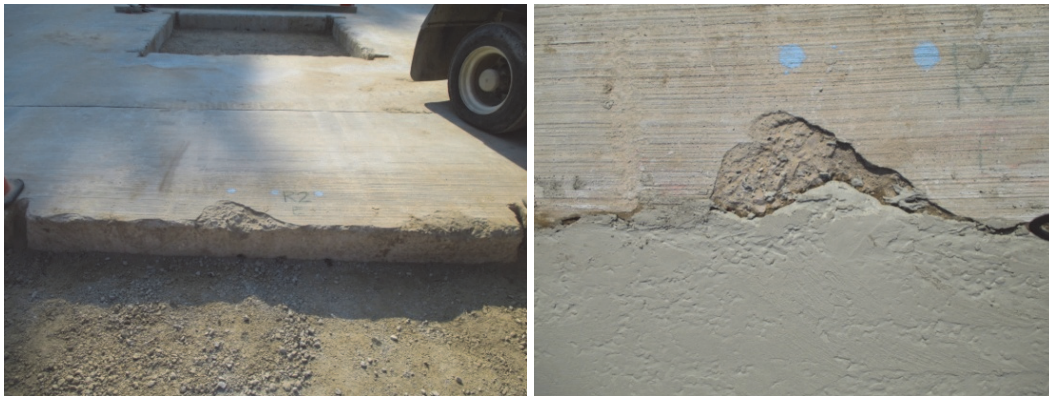
The main mode of failure for Repairs 7-1 and 7-2 was spalling along the transverse joints (joints perpendicular to the direction of travel). Repair 7-1 likely failed prematurely after 2,500 passes due to the condition of the adjacent parent PCC along the east edge of the repair. The parent PCC was severely damaged during the repair process, with spalled areas approximately 6 in. by 6 in. and 0.125 in. deep prior to traffic. During the capping of this repair, rapid-setting concrete was used to partially patch these areas; however, the material quickly deteriorated during the first 500 passes and was not repaired during trafficking. Figure 24 shows the damaged area prior to capping and prior to trafficking. Failure occurred at 2,500 passes (Figure 25).

Figure 24. Spalled parent PCC for Series 2, Repair 7-1 - spalled areas on east edge (left) and partially filled spall prior to traffic (right).

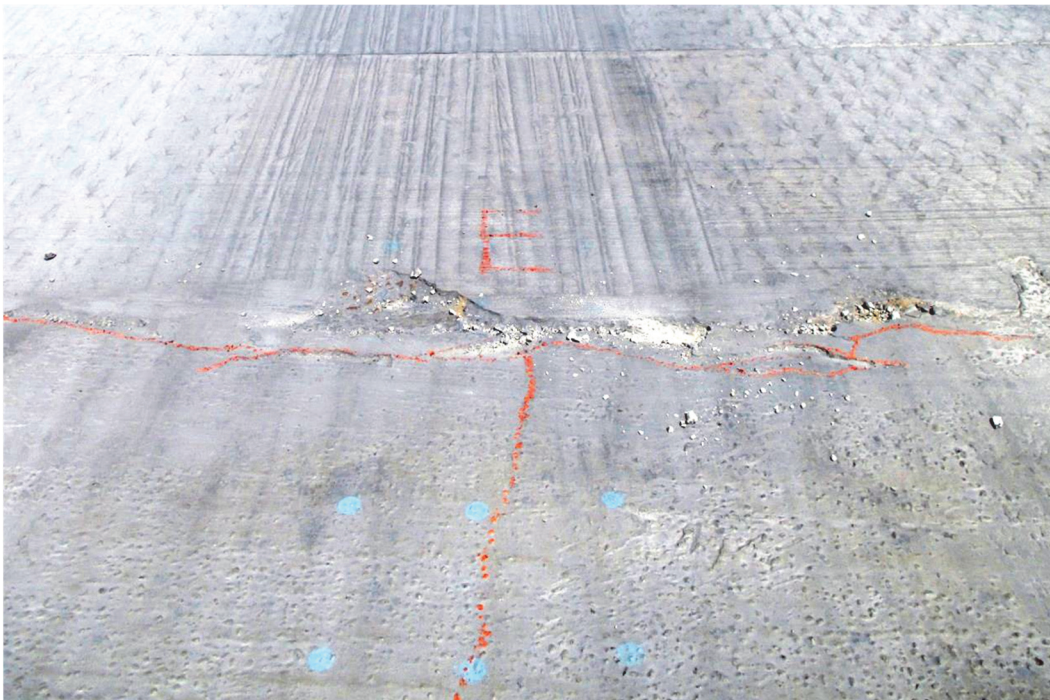
Figure 25. Series 2, Repair 7-1 - overall at failure (2,500 passes).

Repair 7-1 was repeated as Repair 7-2 to determine whether the spalling of the parent PCC slab contributed to an increased spalling rate of the repair. Repair 7-2 traffic was stopped after the application of 3,500 passes due to a tire hazard. The depth and width of the largest spall were 1.875 and 8 in., respectively. It is likely the repair would have met the failure criteria after another 200 to 500 passes. The repeat repair lasted approximately 1,000 more passes than Repair 7-1.

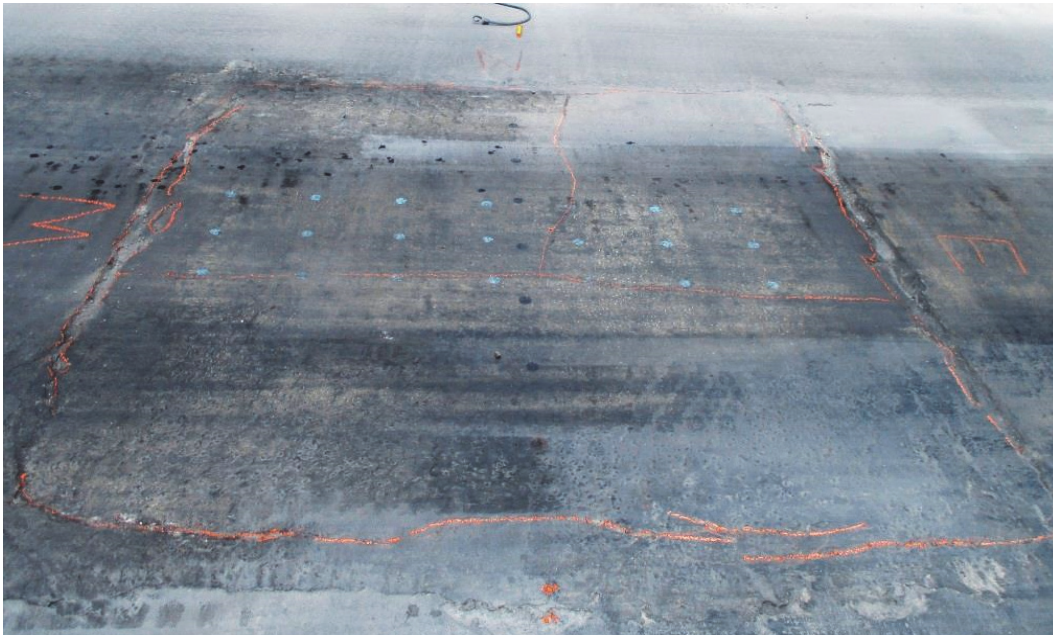
Trafficking of Repair 8 was discontinued following 10,000 passes; however, the repair was close to failure with a maximum spall size of 93 in.

Figure 26. Series 2, Repair 8 - overall at 10,000 passes.

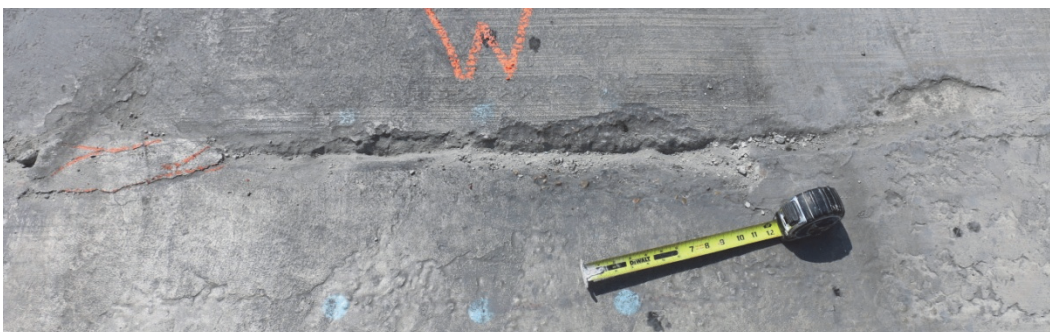
Figure 27. Series 3, Repair 9 - west edge at failure (3,500 passes).

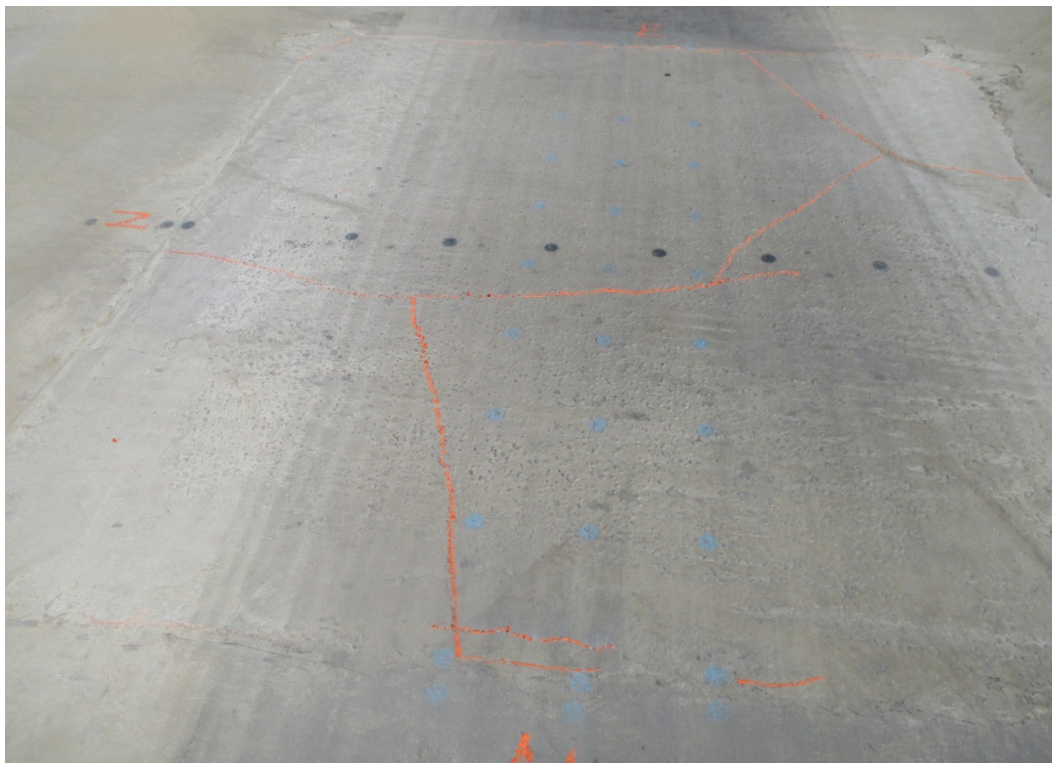
A low-severity shattered slab was noted at 560 passes on Repair 10-1. This did not occur during the Series 2 testing for the same cap thickness over a weaker base material. The shattered slab, however, did not progress in severity and did not result in the repair's failure. Because of the early instance of a shattered repair cap, Repair 10-1 was repeated as Repair 10-2. Repair 10-2 had shrinkage cracks, the longest of which was 46 in., over the repair before trafficking began. Repairs 10-1 and 10-2 were not failed following the application of 10,000 passes. Both repairs had minor spalling along the edges at 10,000 passes. Figure 28 shows the low-severity shattered slab of Repair 10-1 at 560 passes, and Figure 29 shows the Repair 10-1 at 10,000 passes.

Figure 28. Series 3, Repair 10-1 - low-severity shattered slab at 560 passes.

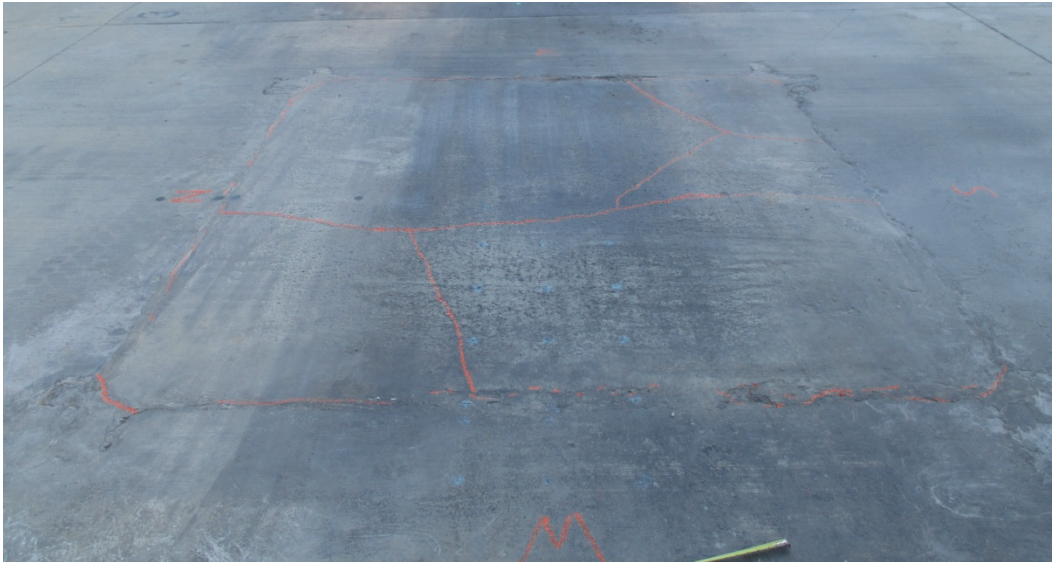
Figure 29. Series 3, Repair 10-1 - not failed at 10,000 passes.

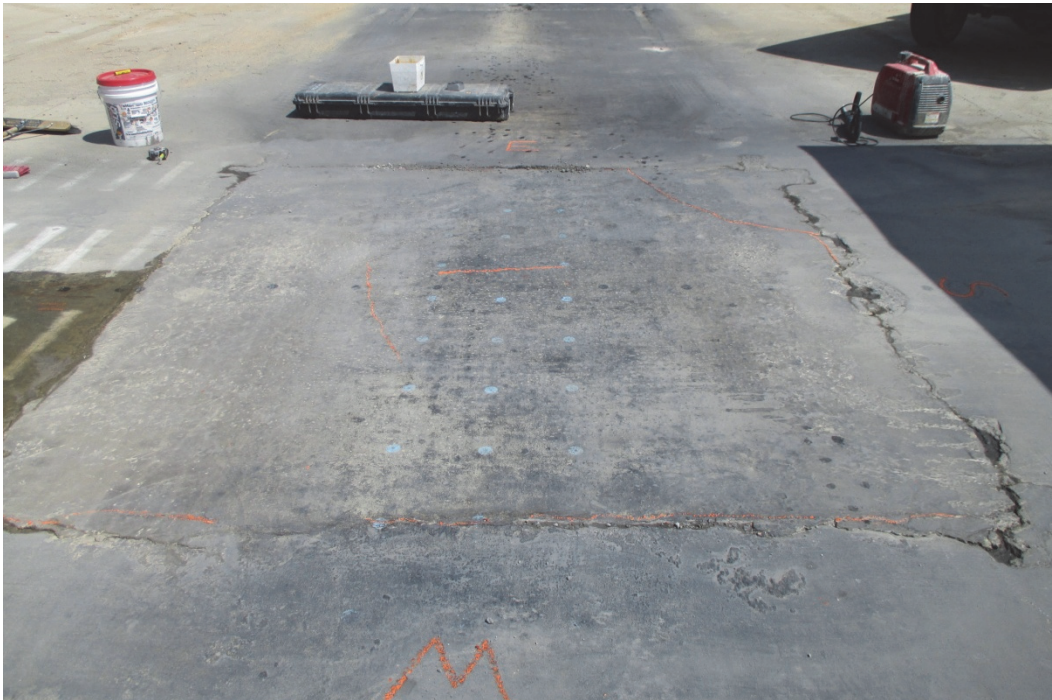
Repair 11 was constructed the same day as Repair 10-1; however, Repair 11 did not have any surface distresses prior to trafficking. A low-severity corner break occurred after the application of 560 passes, and low-severity joint spalling began to develop along the trafficking edges around 4,000 passes. After the application of 10,000 passes, the east edge had a low-severity spall 63 in. long, 2 in. wide, and 0.5 in. deep. Figure 30 shows Repair 11 at 10,000 passes.

Figure 30. Series 3, Repair 11 - not failed at 10,000 passes.

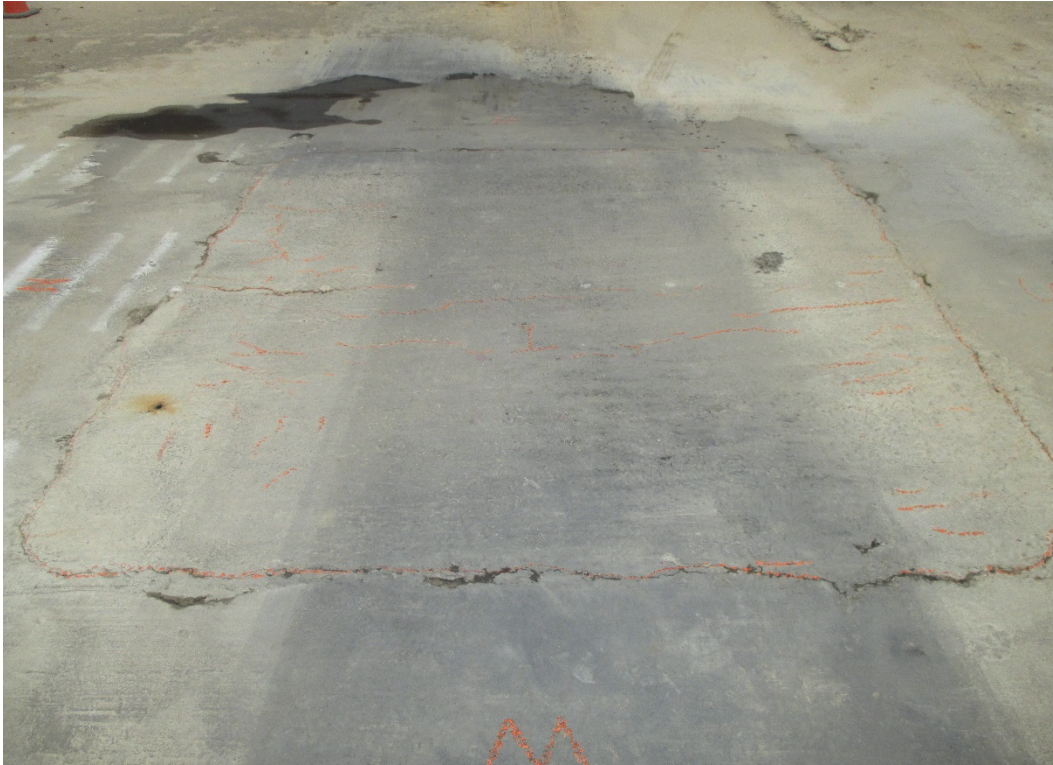
Figure 31. Series 4, Repair 14 - after 10,000 passes.

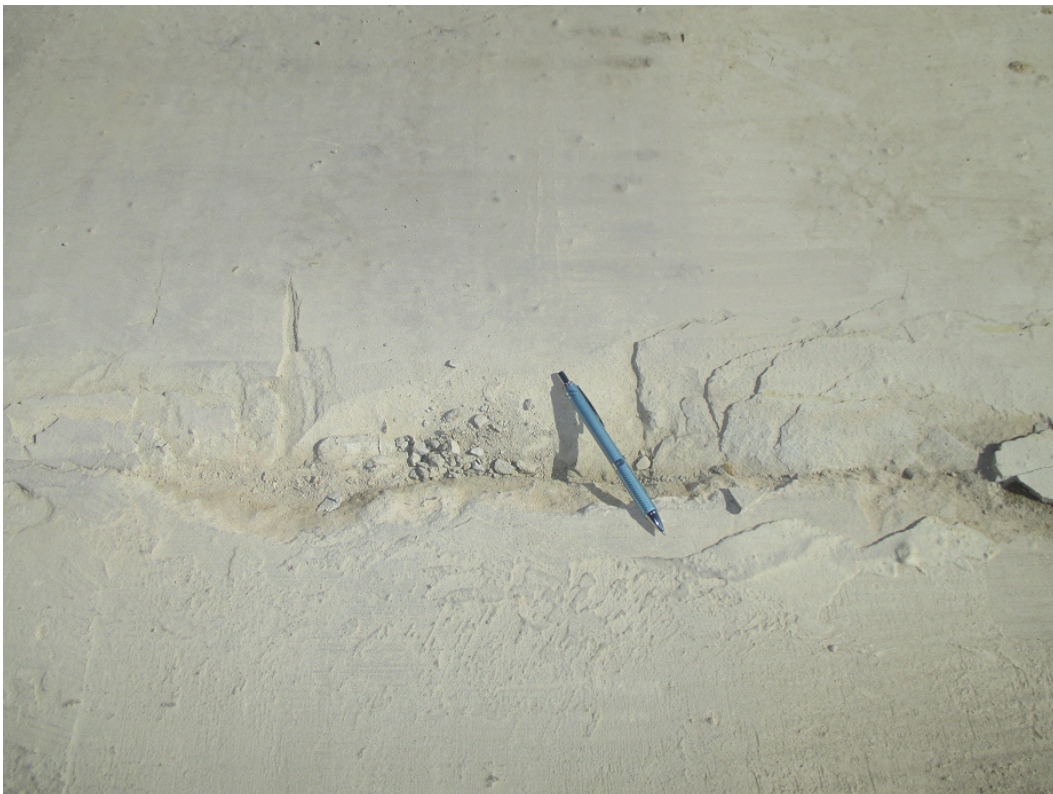
Figure 32. Repair 15 spalling at 800 passes (after being swept).

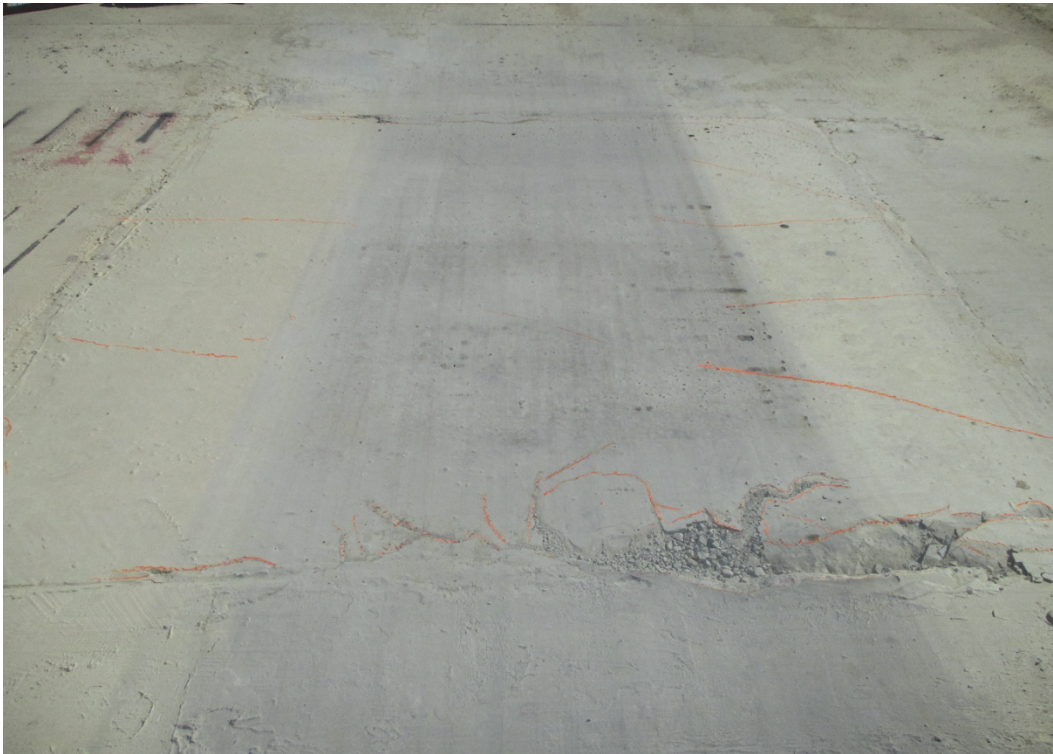
Figure 33. Repair 15 at failure of 1,508 passes.

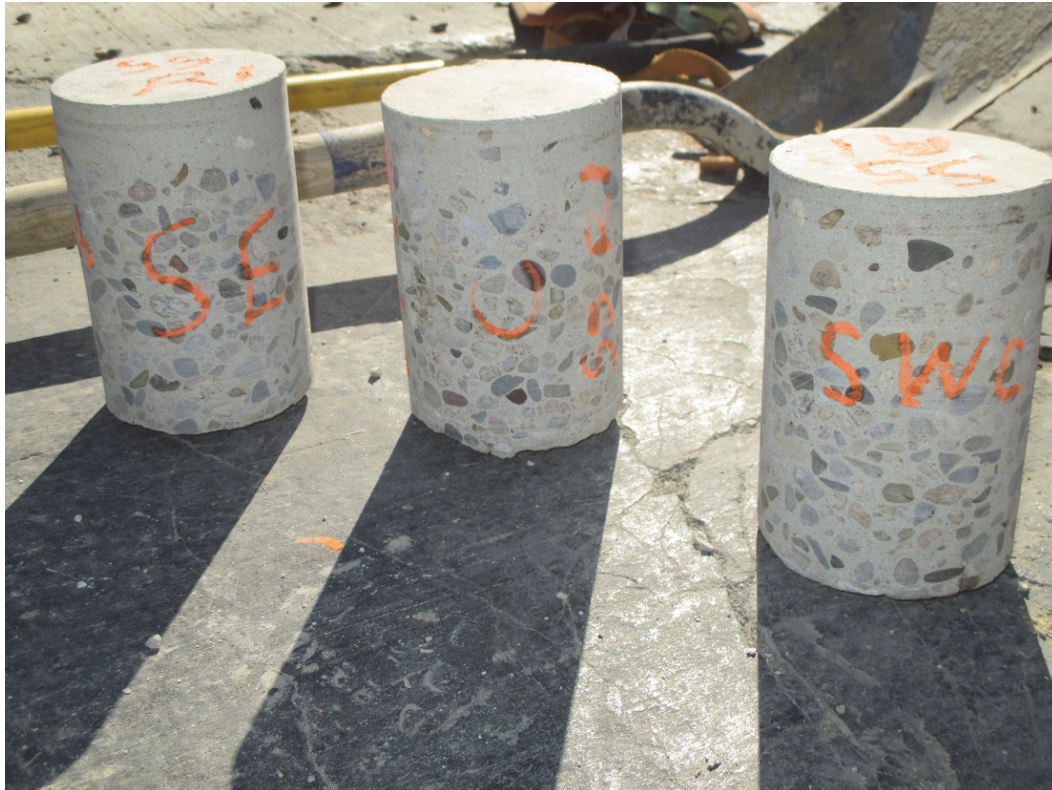
Figure 36. Repair 15 – aggregate segregation of the Rapid Set Concrete Mix® cap.
